**INSPECTION REPORT OF
CONSTRUCTION RELATED ACTIVITIES AT
ST. QUEUNTENS PLANTATION (38BU968),
WALLING GROVE, BEAUFORT COUNTY, S.C.**

**INSPECTION REPORT OF
CONSTRUCTION RELATED ACTIVITIES AT
ST. QUEUTENS PLANTATION (38BU968),
WALLING GROVE, BEAUFORT COUNTY, S.C.**

Prepared By:
Michael Trinkley, Ph.D.

January 17, 1997

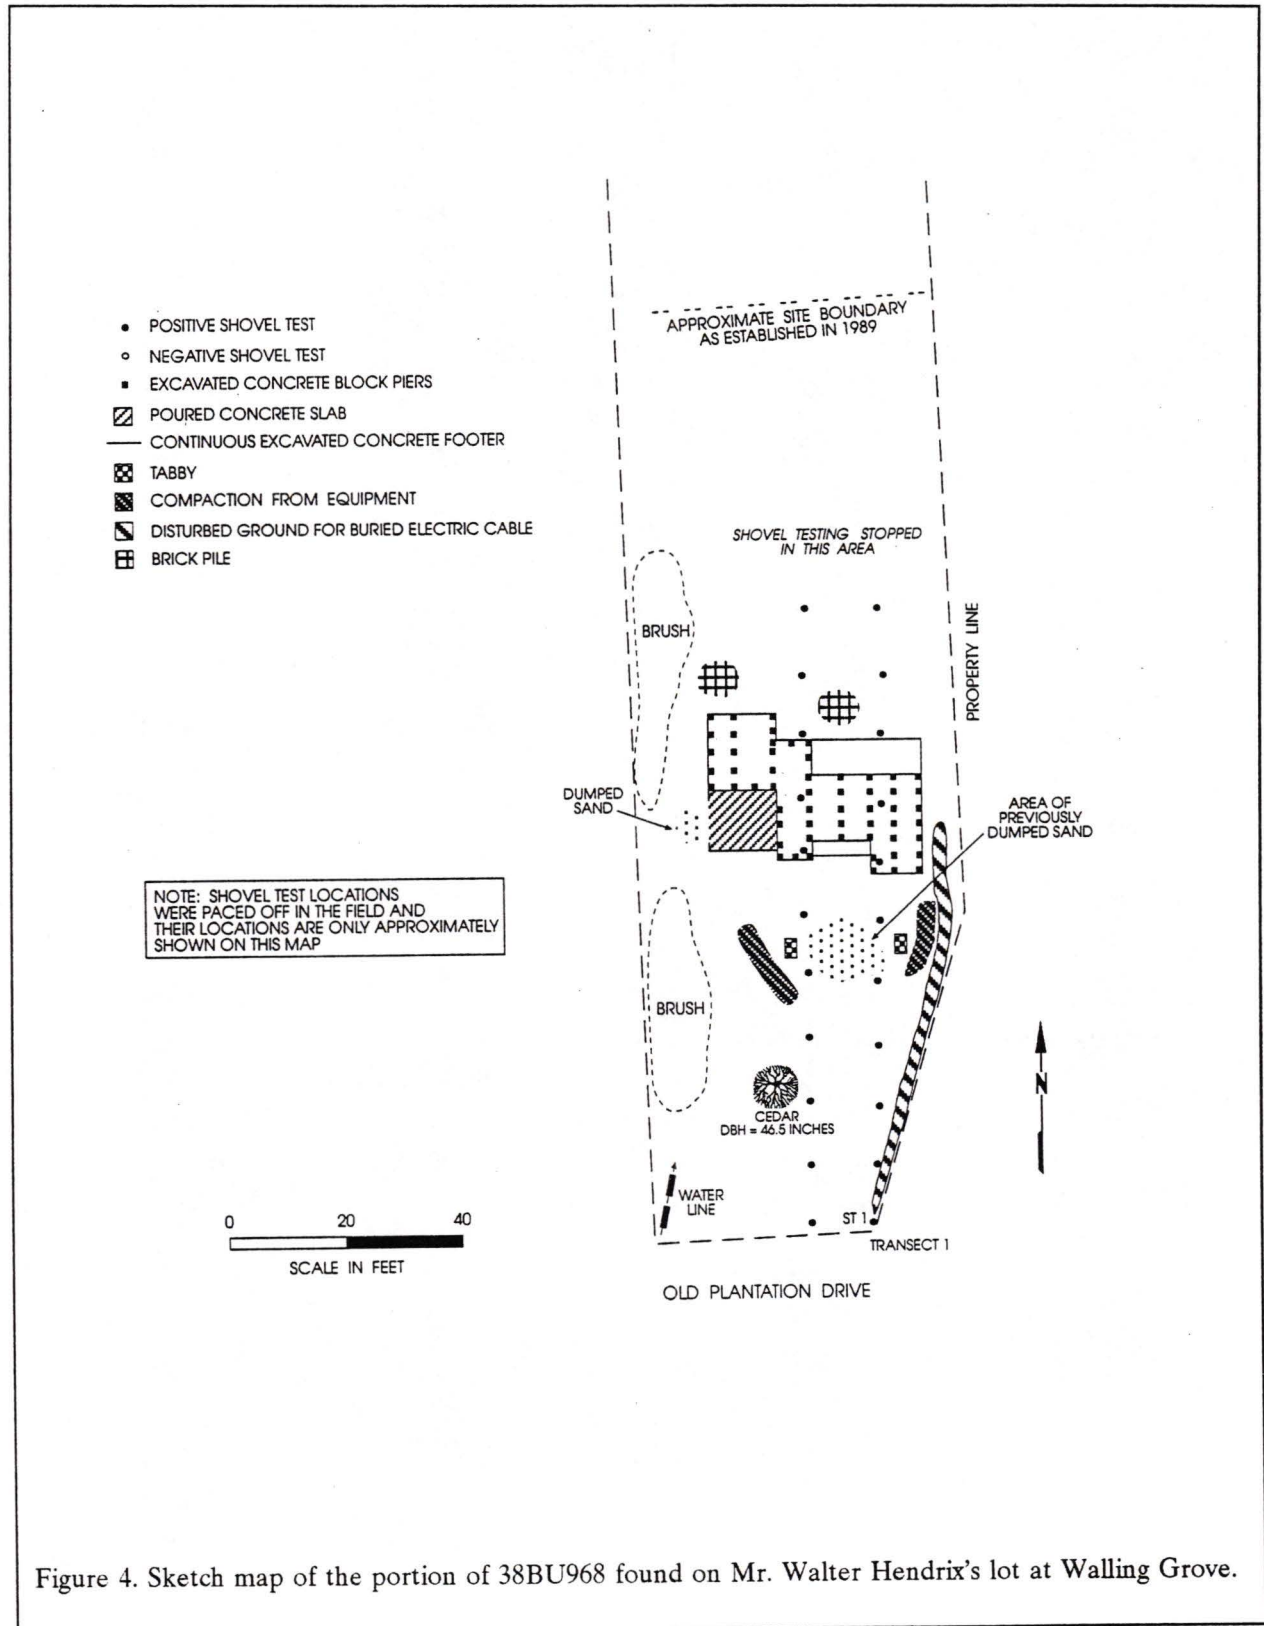
Figure 4. Sketch map of the portion of 38BU968 found on Mr. Walter Hendrix's lot at Walling Grove.

In addition to this continuous concrete footing, there were also a series of interior piers. These were built using concrete blocks, set on poured concrete footers excavated in a similar fashion to the continuous footer. Figures 4 and 8

provide some indication of the number and spacing of these internal piers.

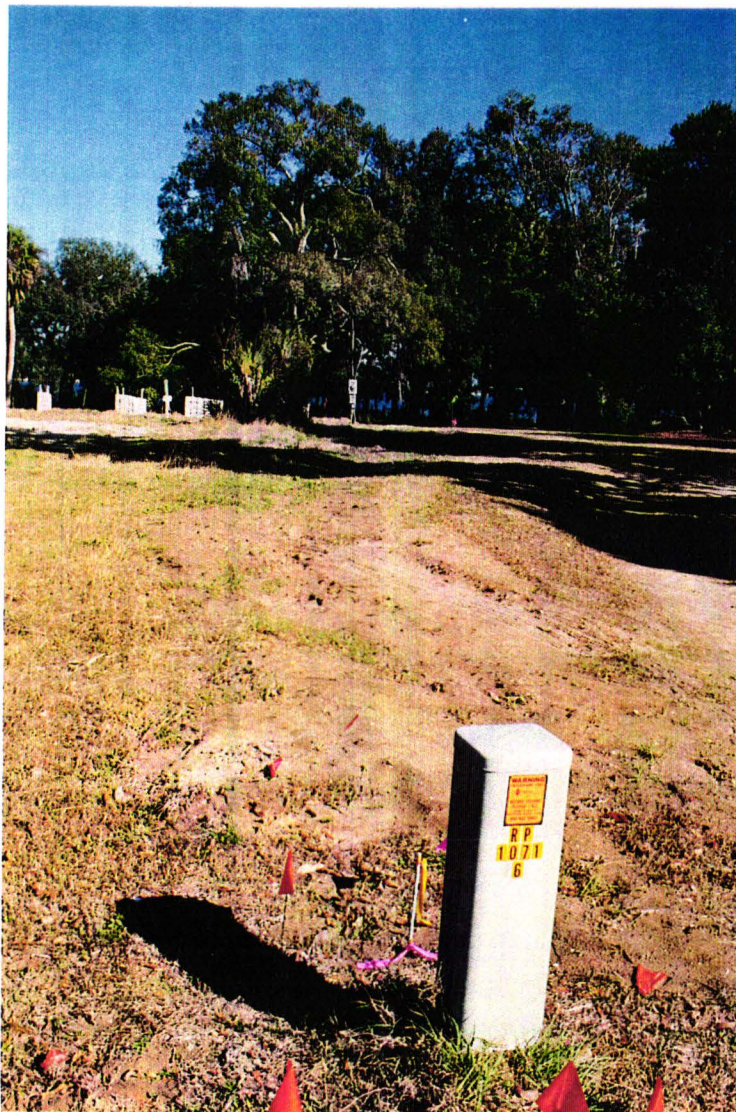
A grab collection of materials exposed in this utility was made during the initial pedestrian survey. About 10 minutes was spent walking this area, collecting those materials which were immediately observed. Collected were 17 specimens, including one decorated delft, four undecorated creamware, one blue edged pearlware, one blue transfer printed pearlware, one undecorated pearlware, one blue hand painted whiteware, one "black" bottle fragment, one aqua bottle fragment, five window glass fragments, and three metal fragments. Also present, but not collected, were occasional oyster shells and brick fragments. All of these remains are consistent with the initial 1989 collection from the plantation and are representative of an eighteenth to mid-nineteenth century time period.

Figure 5. View of utility line along east edge of the lot, from the street to the temporary service pole.

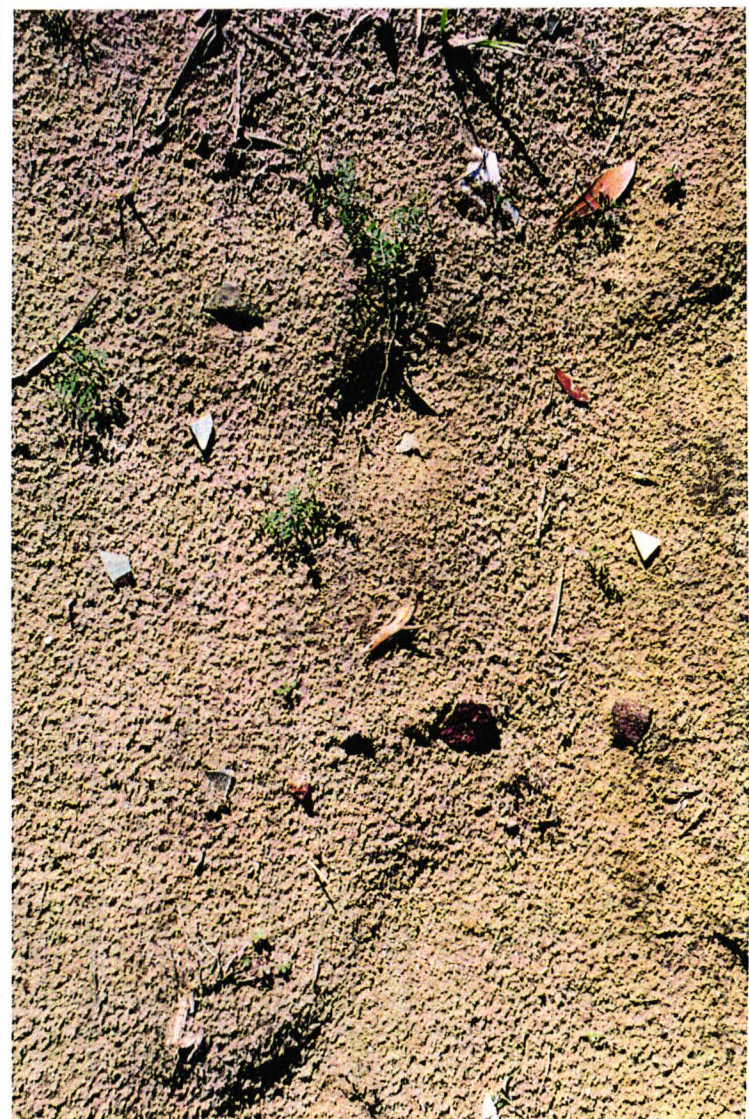
The disturbed area was carefully examined, with a number of artifacts observed on the surface. These were made fairly obvious by either wind or rain action. Some were pedestalled and others were beginning to become visible (Figure 6).

Figure 6. View of ground surface along utility line showing bare soil and artifacts.

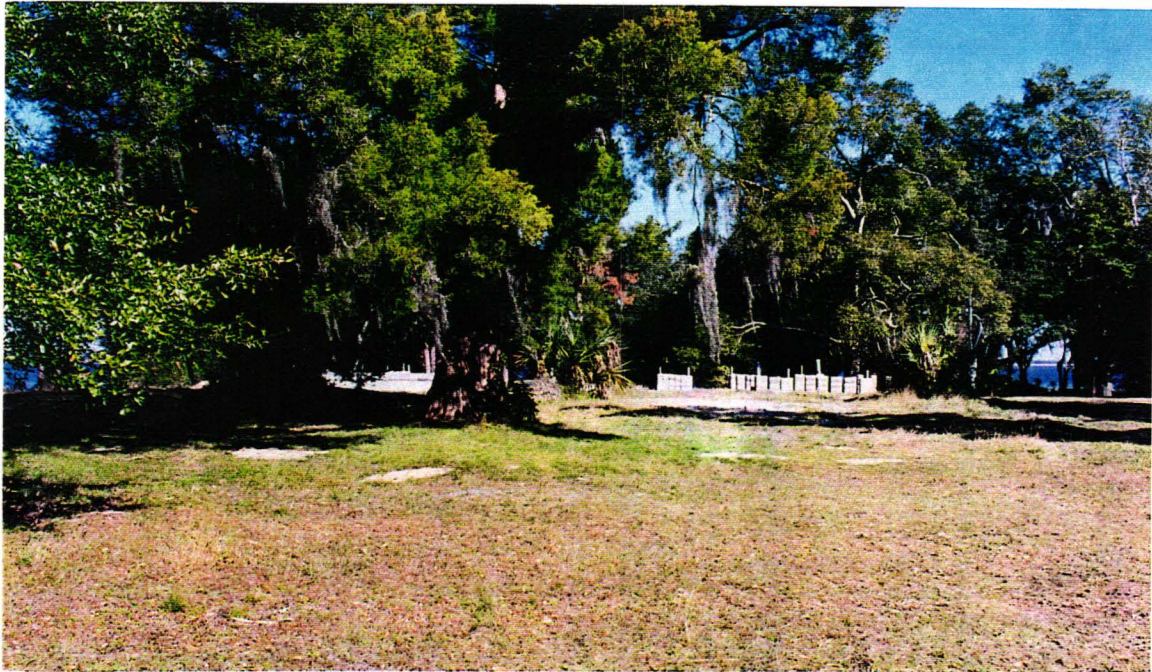
Another immediate observation was the foundation construction in the southern quarter of the lot, about 120 feet from the road. Figure 7 provides an overview of the lot from Old Plantation Drive. The large cedar in the center of the photograph obscures the western half of the foundation, which covers most of the east-west width of the lot.

Figure 7 also reveals that most of the southern portion of the lot is in grass, with virtually no surface visibility. As a result, no artifacts were observed, or collected, from the ground surface in this area. Likewise, the photograph reveals that there is no obvious indication of construction related damage in this area immediately adjacent to Old Plantation Drive.

Figure 7. View of Mr. Hendrix's Lot 1 from Old Plantation Drive looking north, toward the Coosaw River.

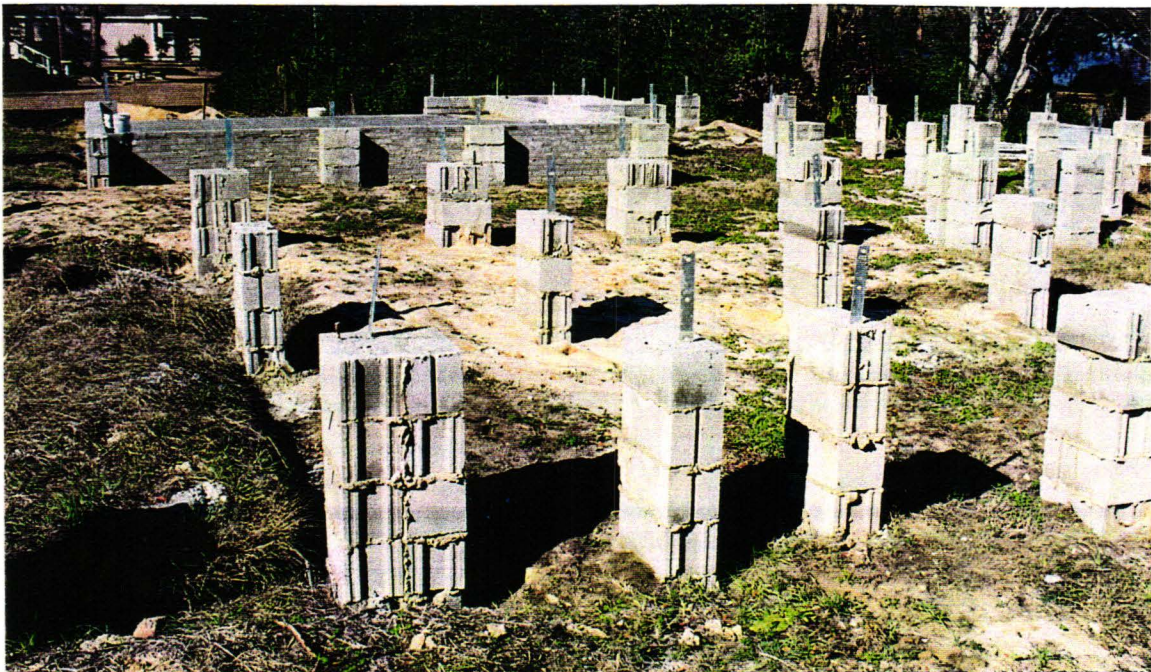
Figure 8. View of the foundations, piers, and slab from the eastern edge of Lot 1, looking to the northwest.

Figure 8 illustrates something of the foundation construction. Evident were both trenches, with a concrete footer and individually set concrete block piers. These cover an area about 92 feet east-west by 62 feet north-south. Also present was a solid concrete slab covering about 675 square feet.

As a result of this activity, there were a variety of disturbed ground areas, although some of what appears to be bare soil is actually construction sand spoil scattered in the area. Bare ground was most often found adjacent to the continuous concrete footer, representing spoil from the trench, as well as a few areas scuffed by construction activities. From the bare areas within the confines of the foundation a grab collection of 11 artifacts were recovered as the result of about 10 minutes of survey. These items include two undecorated whiteware ceramics, one Colono ware sherd, one "black" glass fragment, one brown glass fragment, and two clear glass fragments. These items, like those collected from the utility corridor, are appropriate for the plantation known to exist at this location.

The foundation construction is among the more damaging activities which has taken place on the site. The trenches range about 1.0 to 1.5 foot in width and are at least 1.0 to 1.5 feet in depth. The impact is not limited to the below ground damage, but also includes the mixing of the spoil and creation of a new "construction disturbed" zone. It is likely that some exposed artifacts, especially metal and animal bone, have significantly deteriorated since the trenches were excavated.

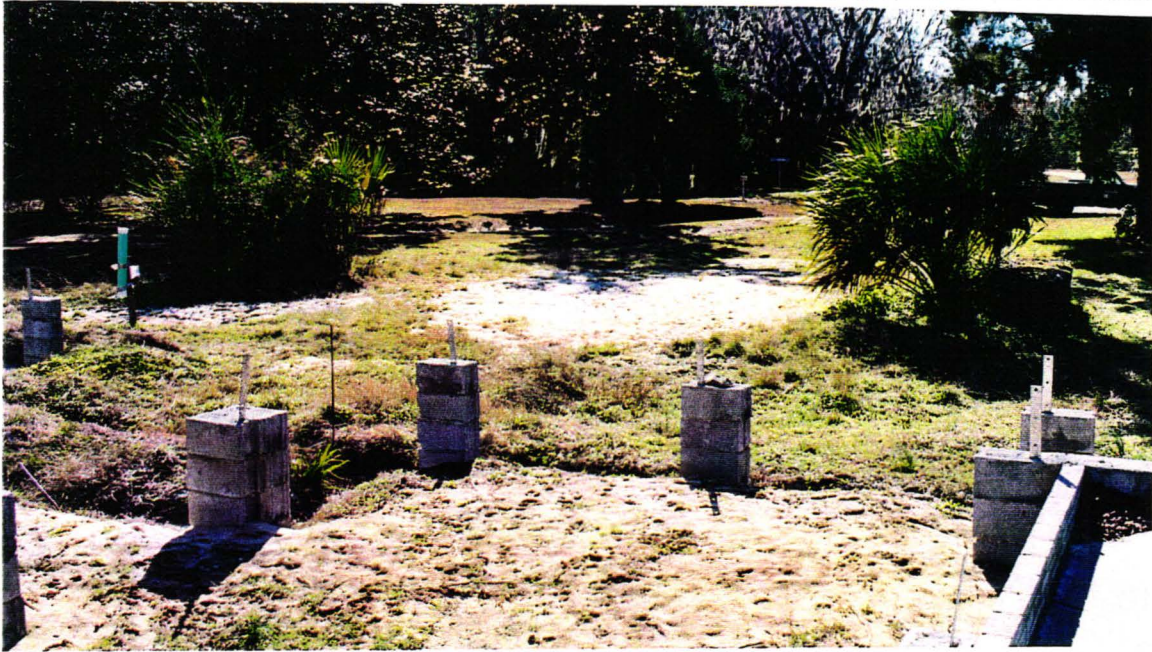
was the location of a large pile of sand, which had been put there sometime early last year and removed this fall, after construction on the house had ceased. When the sand was excavated, the grass underneath was dead and had been to decay, suggesting that the time frame proposed is generally appropriate.

On either side of the tabby chimney footings are very clear ruts and compaction areas. These suggest that construction vehicles accessed the lot from Old Plantation Drive, drove up to the sand pile between the two chimney supports and then went either to the right or left. The drive area was about 4 to 5 feet of the western tabby block. The Gasque and Associates plat of the lot reveals there about 11 feet between the foundation and the east property line, and about 20 feet between the foundation and the west property line.

Figure 9. View of the tabby blocks and sand pile area from the northeast corner of the garage looking to the south-southeast.

The rutting and compaction from construction vehicles was found on either side of the tabby blocks. Currently the impact is moderate, but very localized.

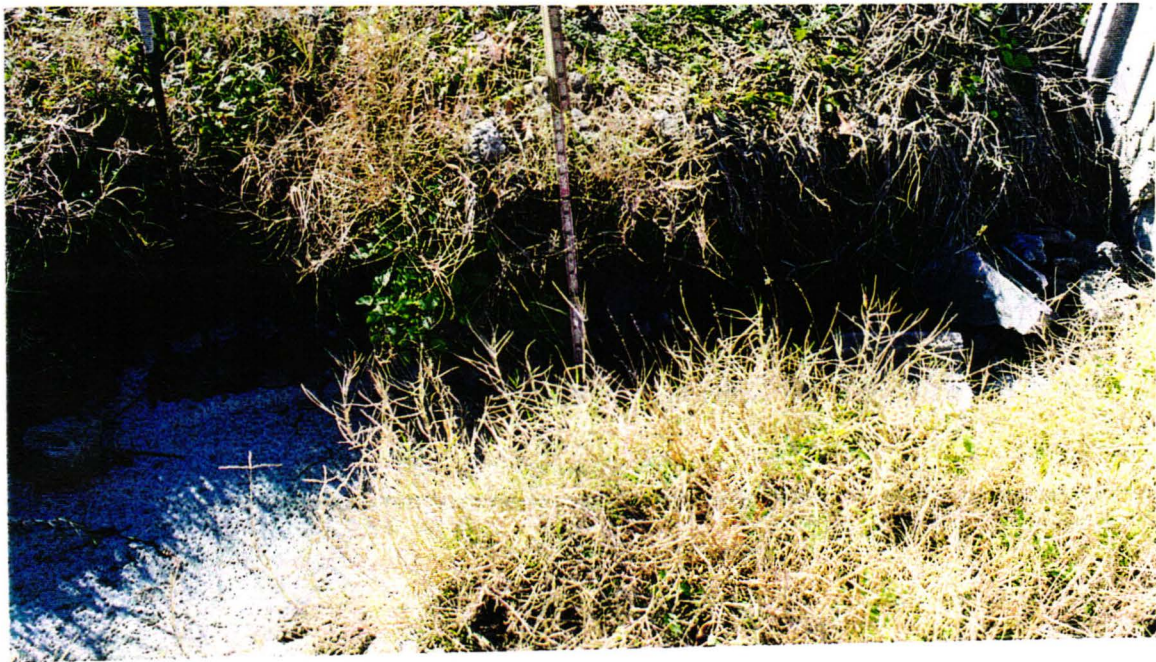
The Hendrix foundation consists of a narrow trench, about a foot in width excavated, I would suppose to support load bearing wall both along the perimeter of the building and in several interior areas. The depth of the foundation excavations is not known, although I measured the depth from the extant ground surface to the top of the concrete pour in two locations — it ranged from about 0.5 to 1.0 foot (Figure 10). Assuming that the trench contained only 0.5 foot of concrete, this means that the excavation was from 1.0 to 1.5 feet in depth. Although I am not familiar with the building code applicable to Beaufort County, typically these extend below frost penetration and are usually no less than 12 inches below the finished grade. Consequently, excavations of 1.0 to 1.5 feet seems reasonable.

Figure 10. View of the continuous footing showing the width and depth of the excavation.

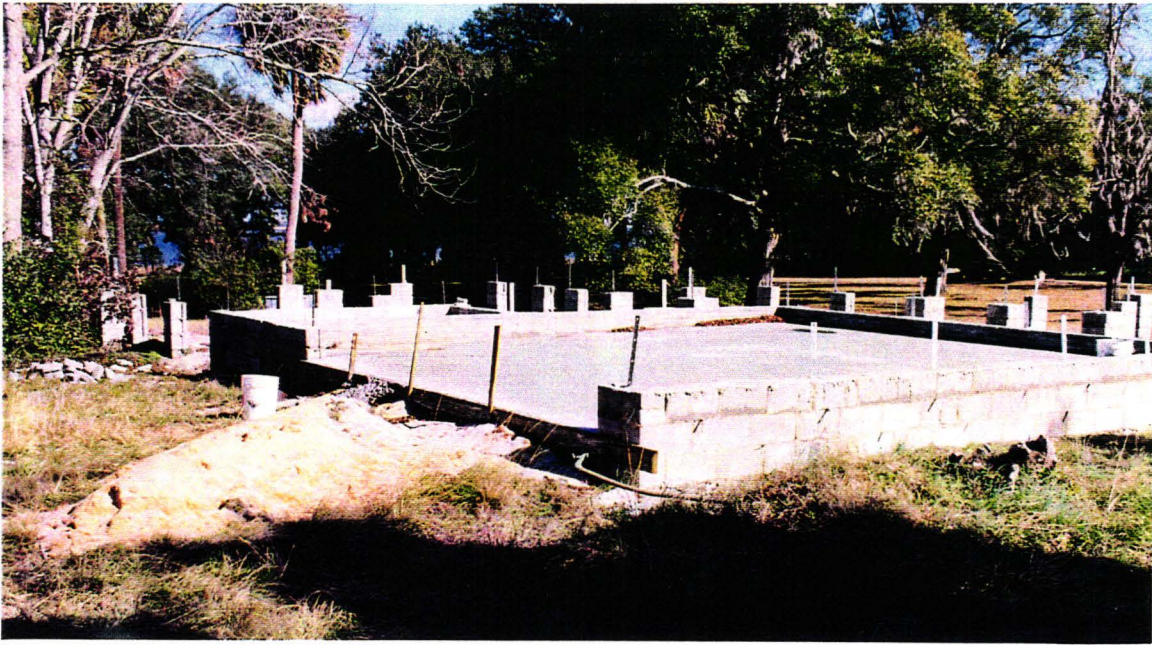
The poured concrete slab for the garage of the structure is above grade. However, Ms. Glace reported that a tree had been cut down in this location and a bulldozer used to remove the stump. The presence of a tree in this area was confirmed by Mr. Hendrix. The use of a bulldozer to grub out roots under slabs seems to be common practice since otherwise there is the potential for cracking and settling as the tree stump and roots decay. This grubbing, however, is particularly damaging to archaeological sites. I have seen large "features" created by such work. Essentially the dozer pulls or pushes up the stump and root system, and then redistributes soil to fill in the void. The equipment is then used to compact the ground the surface.

Figure 11. Poured slab garage, showing its above grade construction. It was in this area that a tree was grubbed out.

This, of course, does not represent the condition of remains under the 675 square foot garage. There the grubbing operations likely destroyed all site context, although this could be explored only by removing the concrete slab — far outside the scope of this investigation.

The tree removal and grubbing of the roots is potentially the most damaging undertaking on the site. In this 675 square foot area it is likely that the site has been destroyed. Consequently, the overlying concrete slab is of relatively little consequence it is only serves to seal an already badly damaged site area.

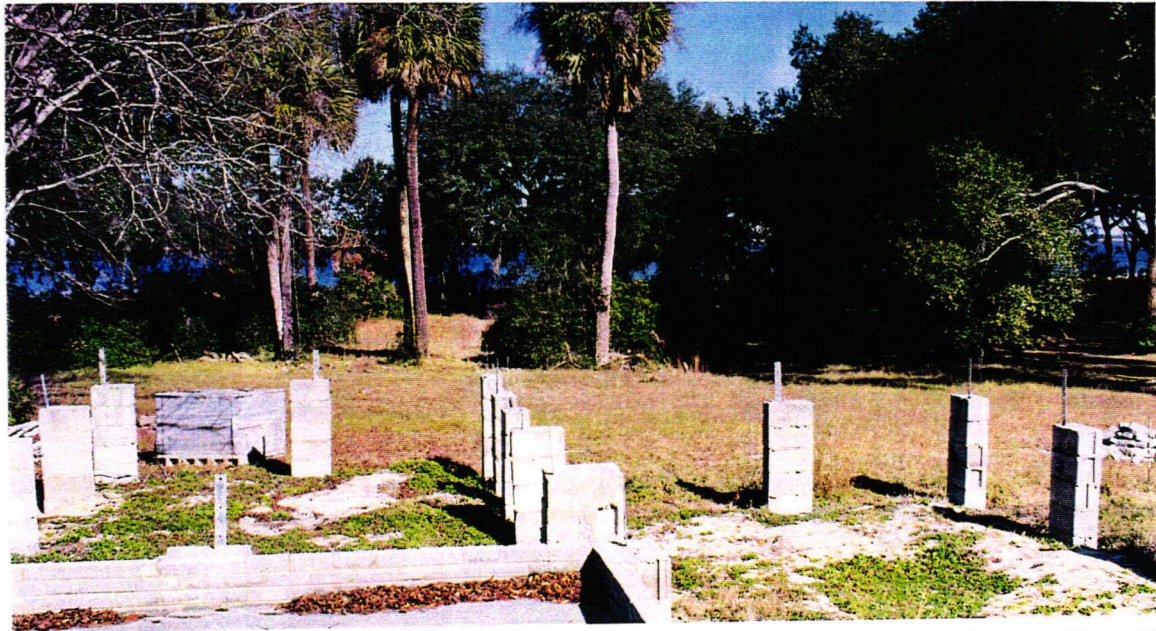
Figure 12. Standing on the southeast corner of the garage floor, looking north to the Coosaw River. Note how the lot drops off. The original site boundary was placed in the vicinity of the palmetto trees. Current testing extended about halfway between the foundation and this series of palmettos.

North of the foundations, the soil profile begins to dramatically deepen. Depths of 1.5 to 1.7 feet were reached without evidence of subsoil. Given the topographic setting — on the slope to the bottom adjacent to the Coosaw — it seems likely that this area was subjected to either overbank deposition or downslope erosion. Either way, it appears that the soils in this area became deeper, as evidenced by the shovel testing. Of course, additional work would need to be conducted to verify, or refine, this scenario.

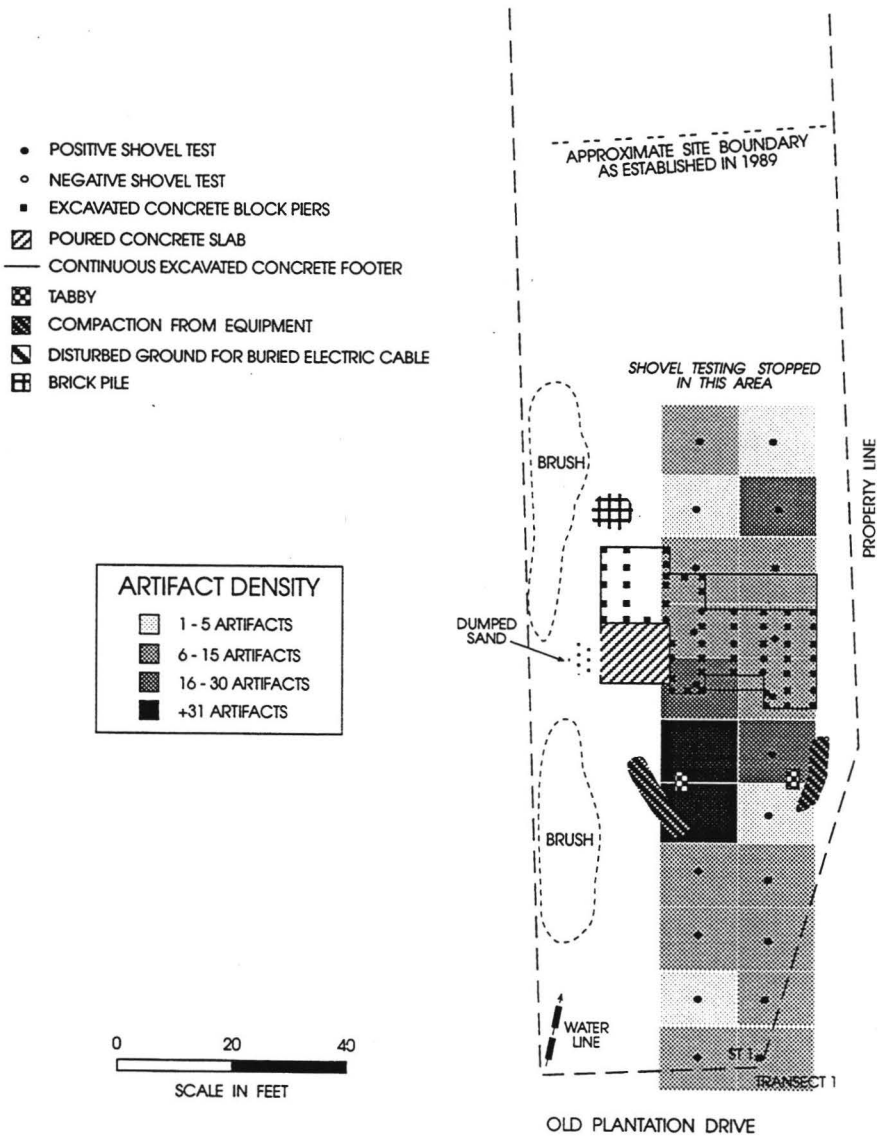
For the purpose of our work brick and tabby have been combined, since both are indicative of structural remains. It's likely, for example, that the tabby chimney foundations supported stacks of fired bricks. Shell which evidenced tabby or mortar fragments was also included in this architectural category, otherwise it was tabulated separately as shell. Figure 13

The "near rear yard" of the ruins, which also correlates with Mr. Hendrix's foundation, reveals artifact densities ranging from 8 to 15 specimens — very similar to the "front yard" range.

Figure 13. Artifact density in the tested area on the Hendrix lot at Walling Grove.

All of the data support the conclusion that artifact density is high in the vicinity of both the ruins and the current foundation construction. There is no real difference in site density between the two areas.

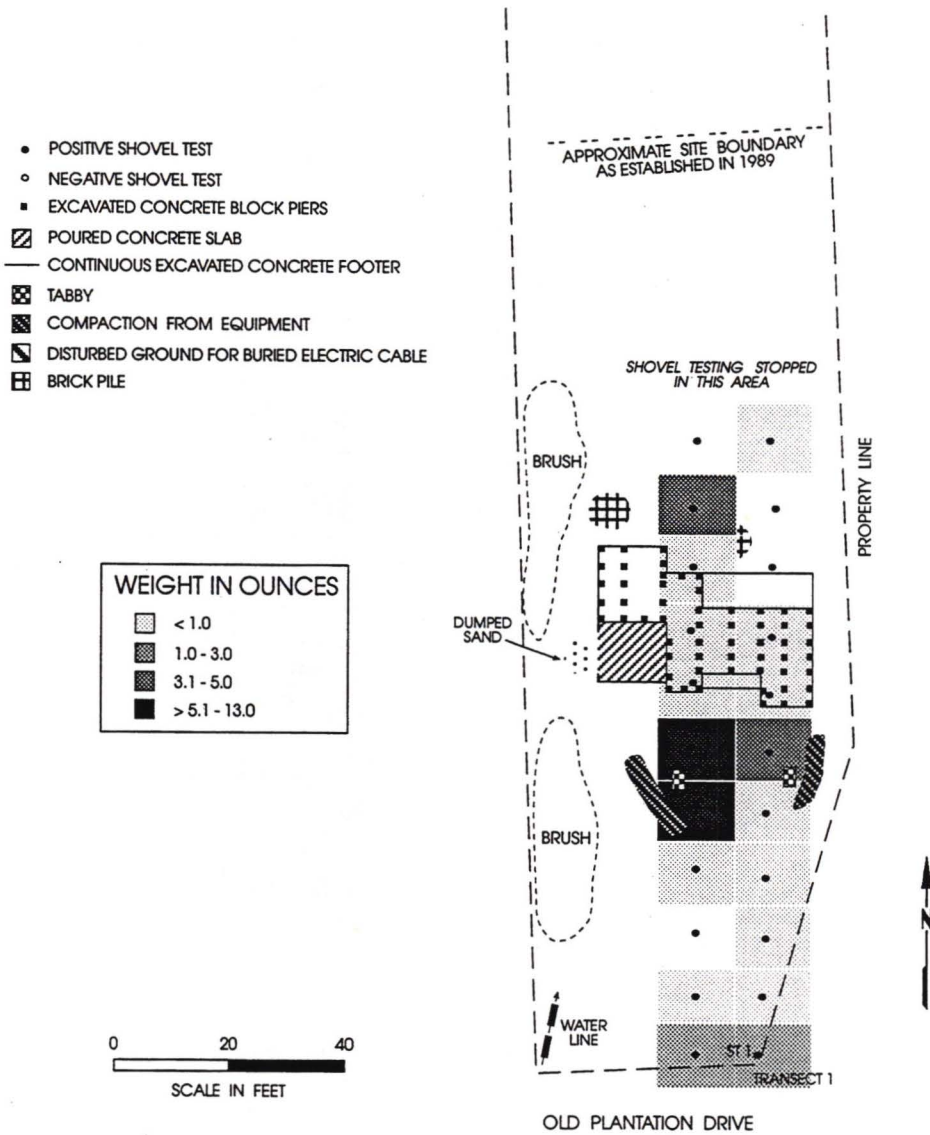
Figure 14. Brick and tabby rubble density in the tested area on the Hendrix lot at Walling Grove.

Figure 14 reveals a somewhat dispersed distribution of brick and tabby. There is a relatively clear concentration in the immediate vicinity of the ruins. The association with the ruins is appropriate, since it is likely that a fairly substantial amount of rubble resulted from the two chimney falls, break up of the foundation walls, and removal of internal piers. It seems that the architectural rubble declines in density as one moves away from the main house, although there is a slight increase along the road (to the south) and just north of Mr. Hendrix's house. The meaning of these two possible concentrations cannot be discerned with the available data.

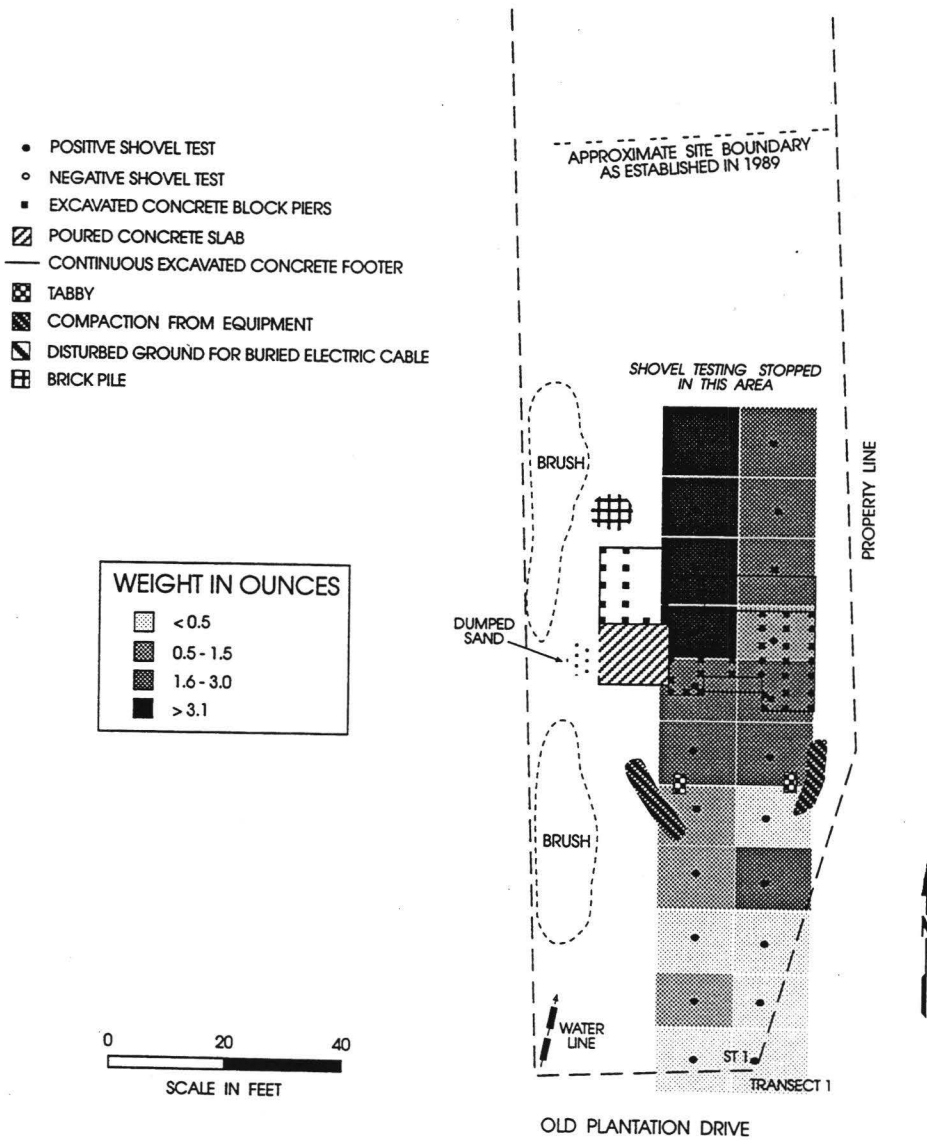
Figure 15. Shell density in the tested area on the Hendrix lot at Walling Grove.
